SS7000[™]

SFA7700[™]

Interposer Issue with SanDisk Lightning SSDs

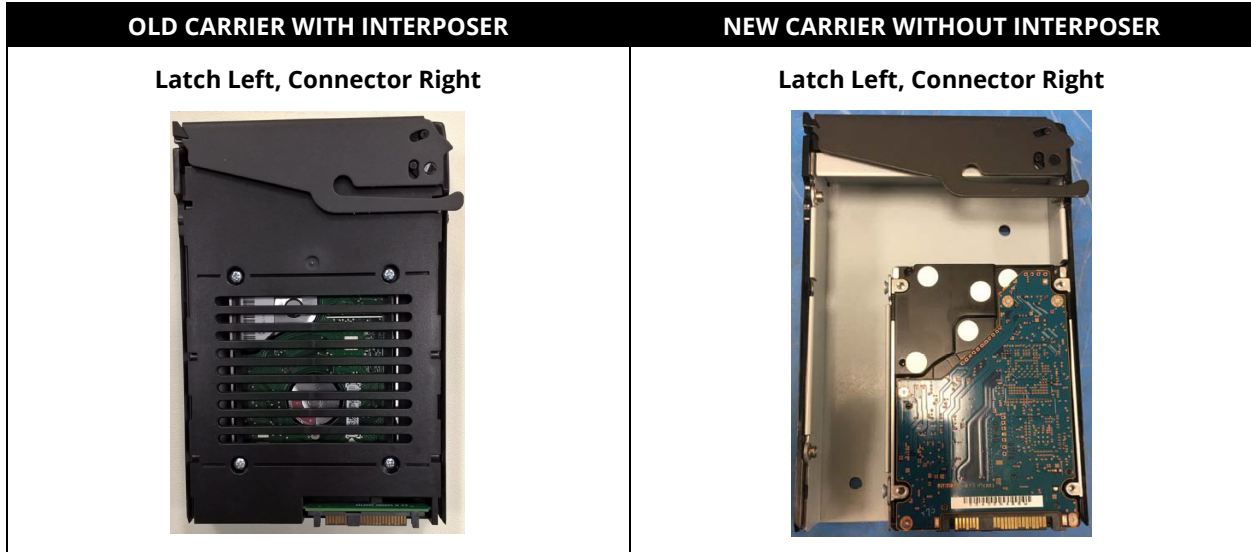
Table 3. Comparison of Old and New SS7000 Carriers for 2.5" SAS Drives

When the failed SSD is removed from its carrier and inserted directly in a drive slot on the enclosure baseboard, it performs as expected. In these cases, the timeout issue has been traced to the interposer in the original SS7000 carrier.

SAS socket position on the enclosure baseboard. That interposer is designed to operate at 3 Gbps to 6 Gbps. The SAS connections on the SS7000 baseboard also operate at 6 Gbps. However, SanDisk Lightning SSDs are optimized for operation at 12 Gbps. SFA OS negotiates the speed of these drives down to 6 Gbps to match enclosure requirements. But SS7000 interposers do not always accommodate the narrow timing tolerances of these high-speed-capable drives and can sometimes introduce signal errors.

Step 3. Verify that the candidate drive is installed in an old carrier with the 6 Gbps interposer. The two carriers can be identified by visual inspection, as shown in Table 3.

This issue is resolved by replacing older SS7000 carriers for 2.5-inch drives a new SS7000 carrier. The new carrier uses a mechanical adapter to position any 2.5" form factor SAS drive so that it connects directly to the SS7000 enclosure baseboard. No interposer is required. All new SSD shipments destined for SS7000 enclosures or SFA7700 head enclosures now use the new carrier.

If the candidate SanDisk SSD is mounted in the old carrier, contact DDN Support to arrange carrier replacement.
